**AFRL-ML-WP-TR-2000-4097**

**EFFECTS OF BALLISTIC IMPACT DAMAGE  
ON FATIGUE CRACK INITIATION IN  
Ti-6Al-4V SIMULATED ENGINE BLADES**

**APRIL 2000**

Wright-Patterson AFB , OH 45433-7750
<b>13. SUPPLEMENTARY NOTES</b> Thesis submitted to the School of Engineering University of Dayton
<b>14. ABSTRACT</b> This study characterizes damage caused by ballistically impacting spherical glass beads on leading edges of simulated engine blades and correlates it to their high cycle fatigue strength.
<b>15. SUBJECT TERMS</b> high cycle fatigue; turbine engine blades

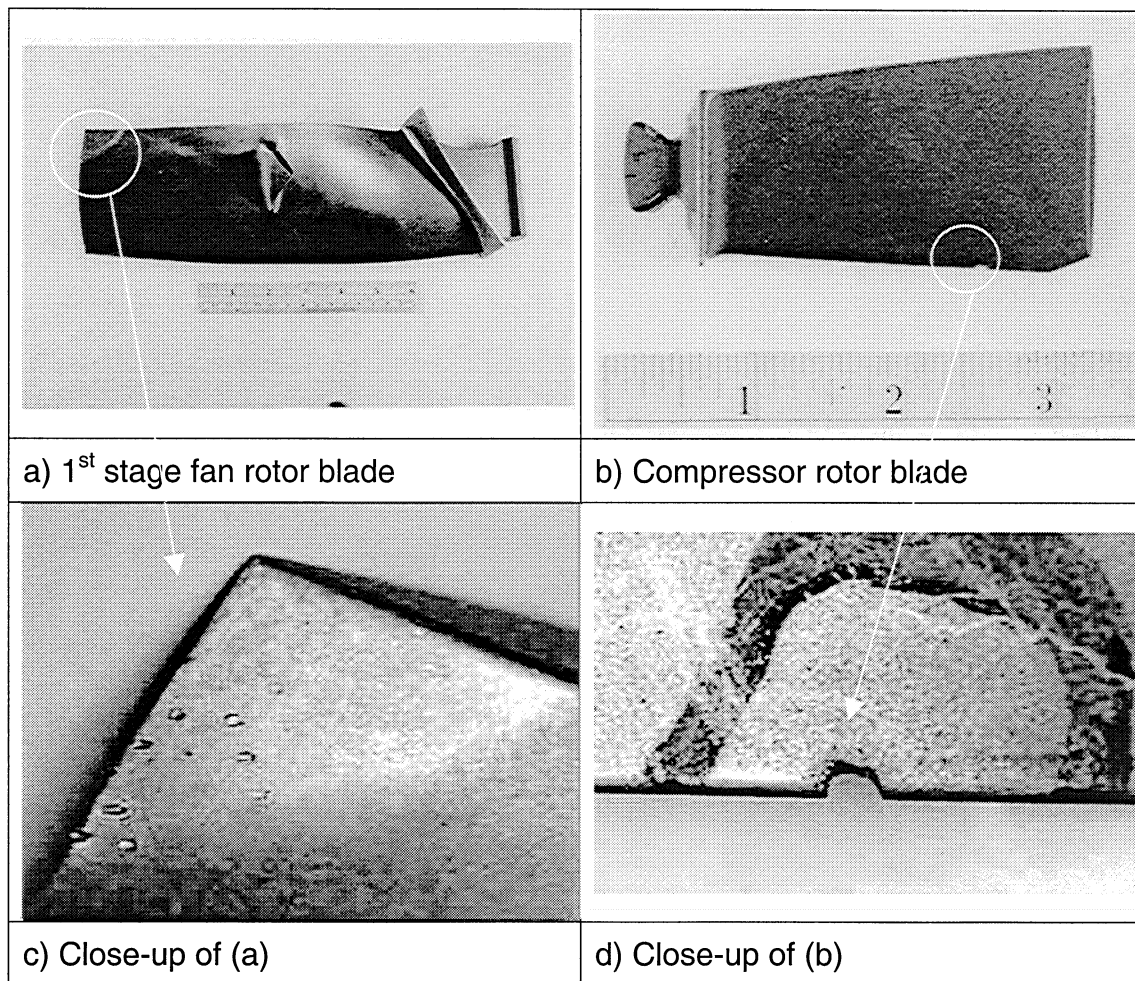
Figure 1: In-service FOD (blades from the F-110-GE-100 engine)

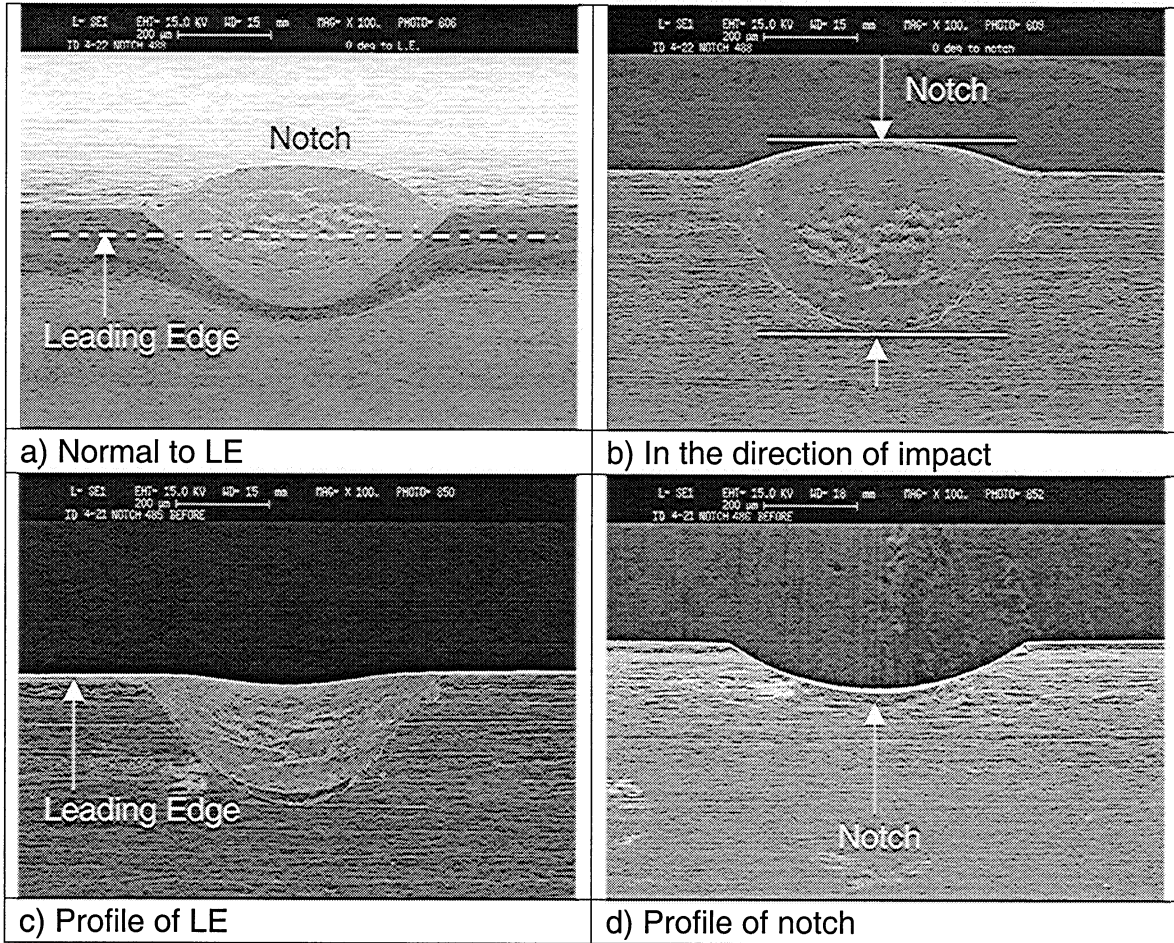
Figure 11: Un-failed notch for sample 4-22, with a sharp LE and a 30° impact

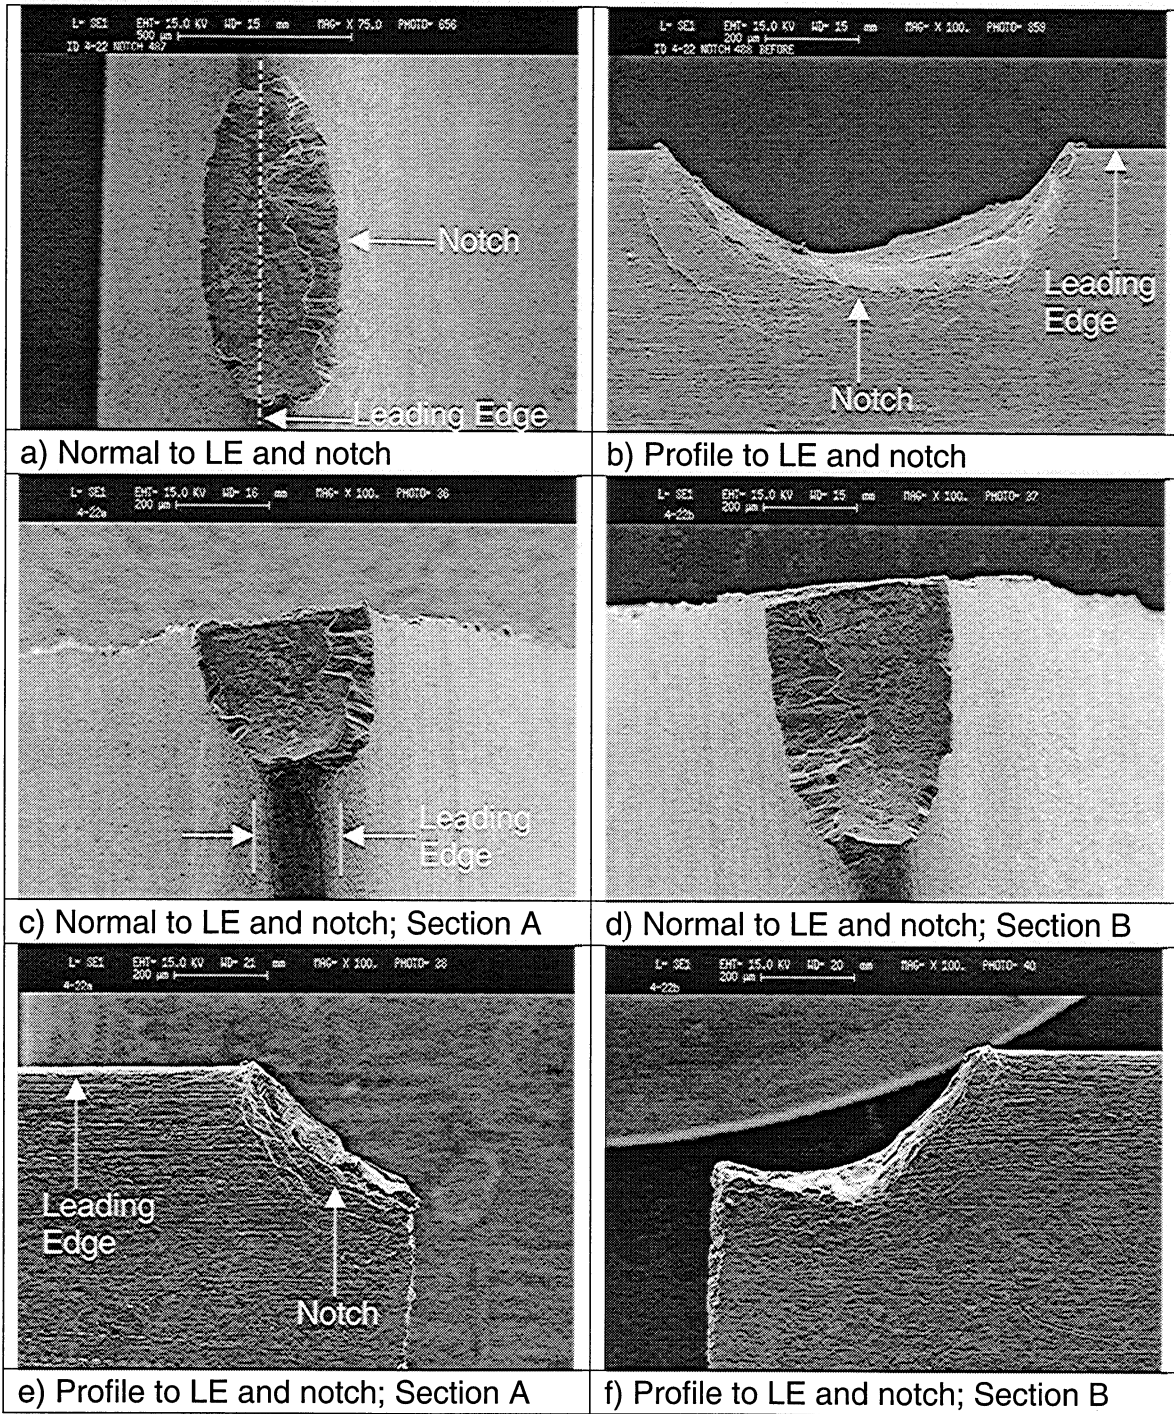
Figure 12: Failed notch for sample 4-22

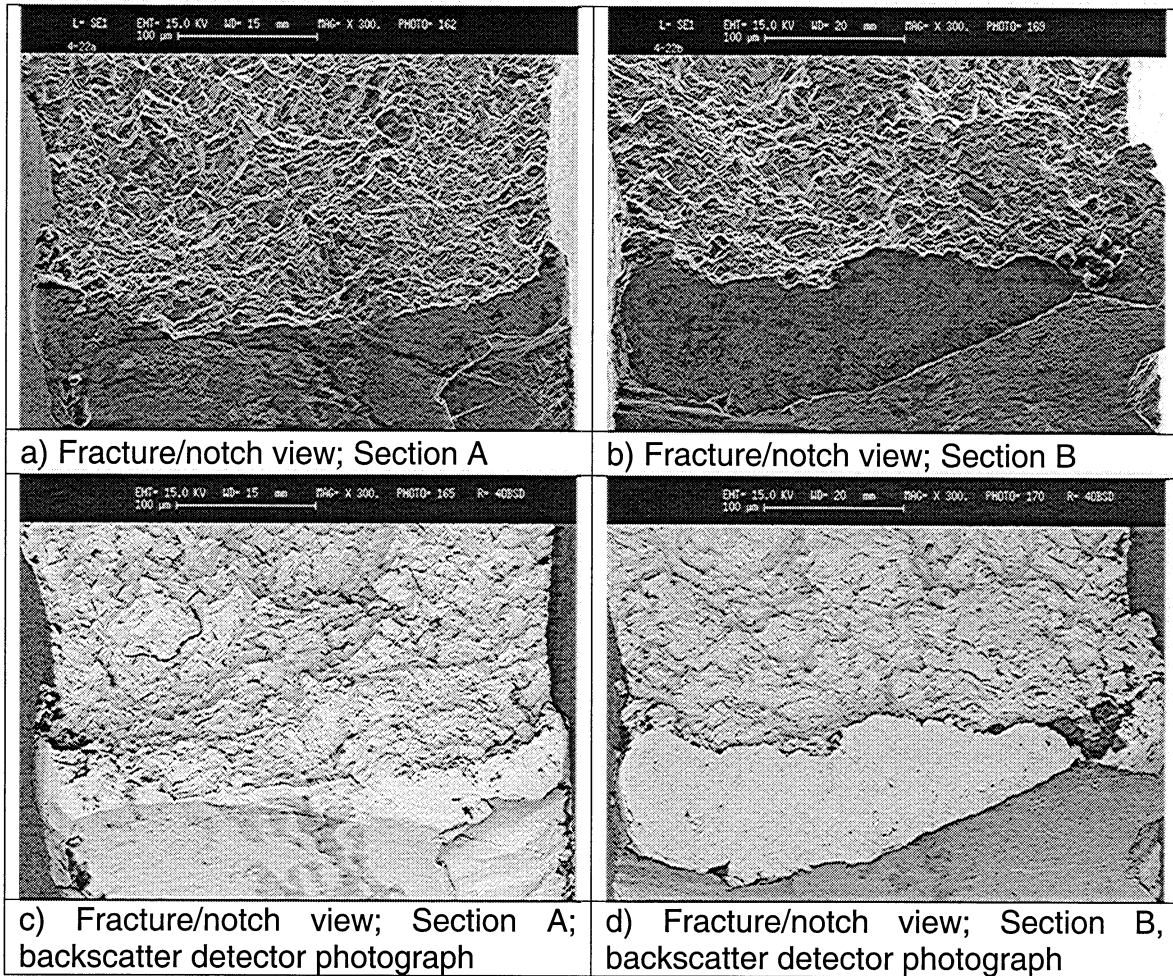
Figure 13: Fracture views of failed notch for sample 4-22

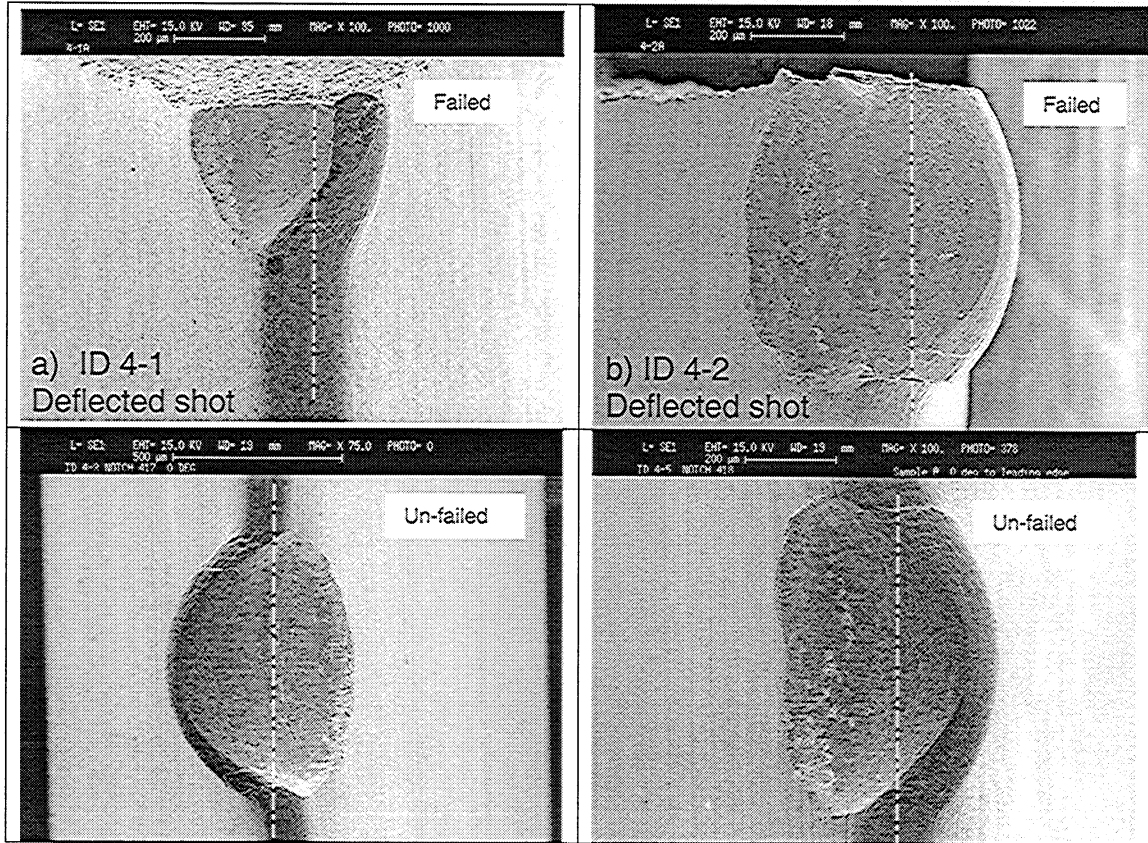
Approximately 80% of the 0° shots fired at the sharp LE samples did not hit the leading edge head on, but were off center as shown in Figure 18b. Figure 19 and Figure 20 show photographs of representative 0° impacts for both the sharp and the blunt edges. In each of those pictures the top photo shows the failed notch, and the bottom is that of the un-failed notch. The center of the LE is

indicated by the dashed line. The off center shots create little damage to the leading edge. Instead the material is shifted to one side, possibly leaving behind residual compressive and tensile stresses similar to that of an angled shot shown in Figure 17b and Figure 18b. As expected, the sharp edge is difficult to hit head on. Consequently, none of the  $0^\circ$  impacts hit the LE head-on, instead they impacted on one side of the LE, compressing it as suggested in Figure 19. This may be one reason why the  $0^\circ$  impact samples showed higher fatigue strength than the  $30^\circ$  impact samples, especially for the sharp edge samples. In this case, there might be a higher level of residual compressive stresses than a typical angled impact, because the bead compresses the material to one side instead of shearing it from entrance to exit.

Figure 19: Sharp LE with 0° impacts showing both failed and un-failed notches.

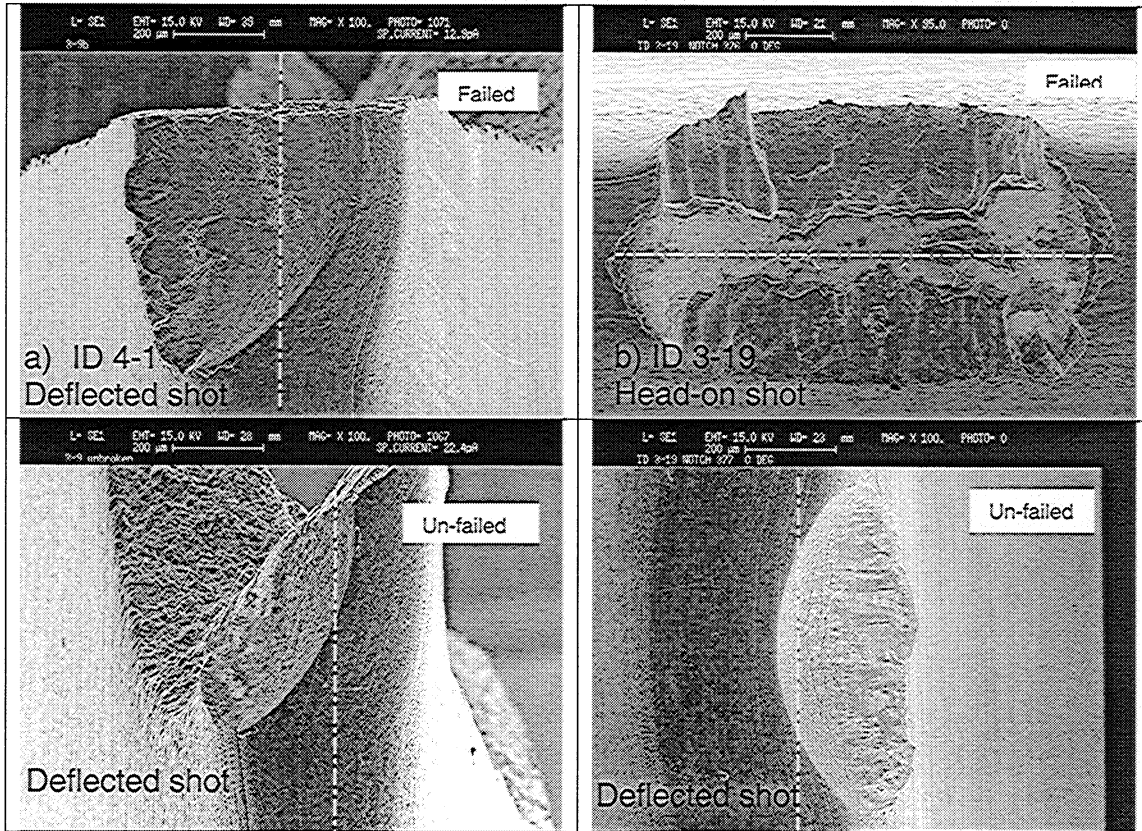
Since the blunt LE is wider, 25% of the  $0^\circ$  impacts actually hit the LE head-on, with the remaining 75% resembling those of angled or  $30^\circ$  impacts on blunt edges, shown in Figure 20. These  $0^\circ$  impacts produced more damage on the blunt edge than those for the sharp edge. The similarity in fatigue strength debit between the  $0^\circ$  and  $30^\circ$  impacts for the blunt LE could be due to the fact that the damage from  $0^\circ$  impacts resemble that of damage from  $30^\circ$  impacts.

Figure 20: Blunt LE with 0° impacts showing both failed and un-failed notches.

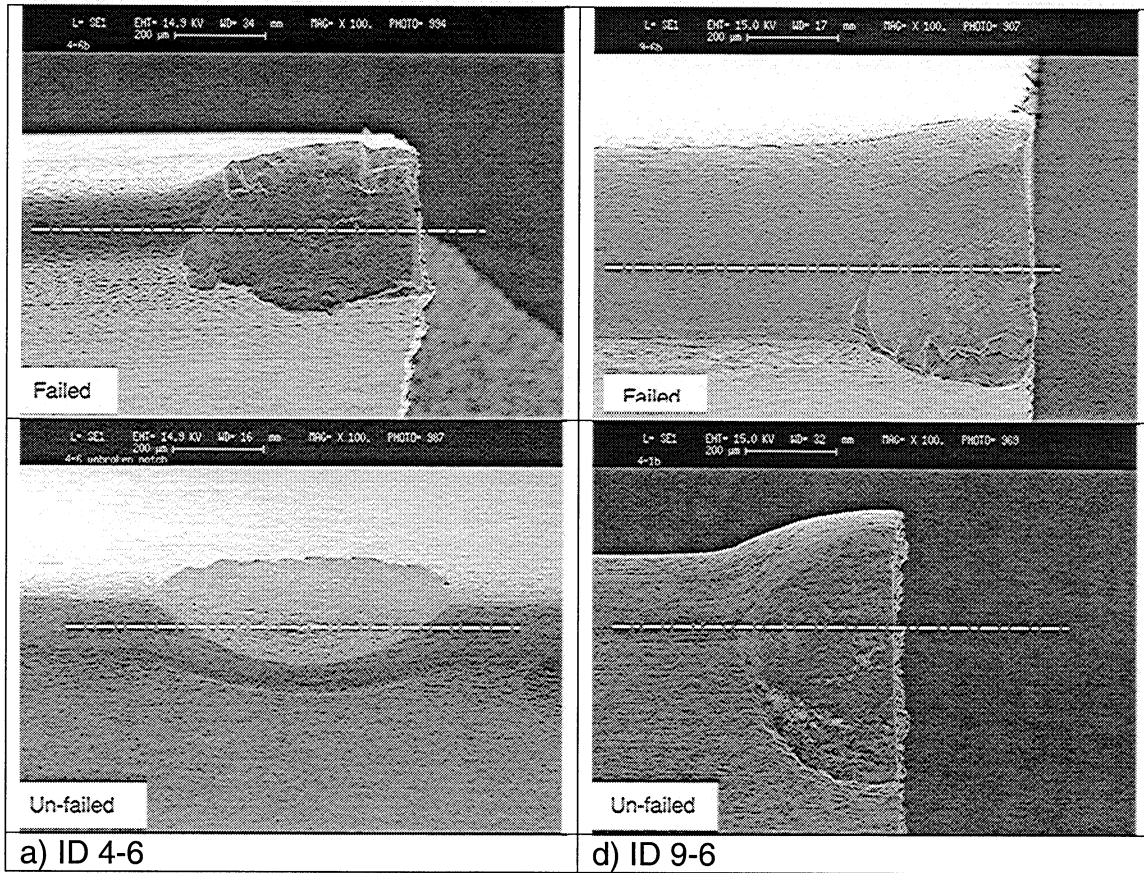
Figure 21: Samples with 30° impacts showing both failed and un-failed notches.

a) Sharp LE; b) Blunt LE

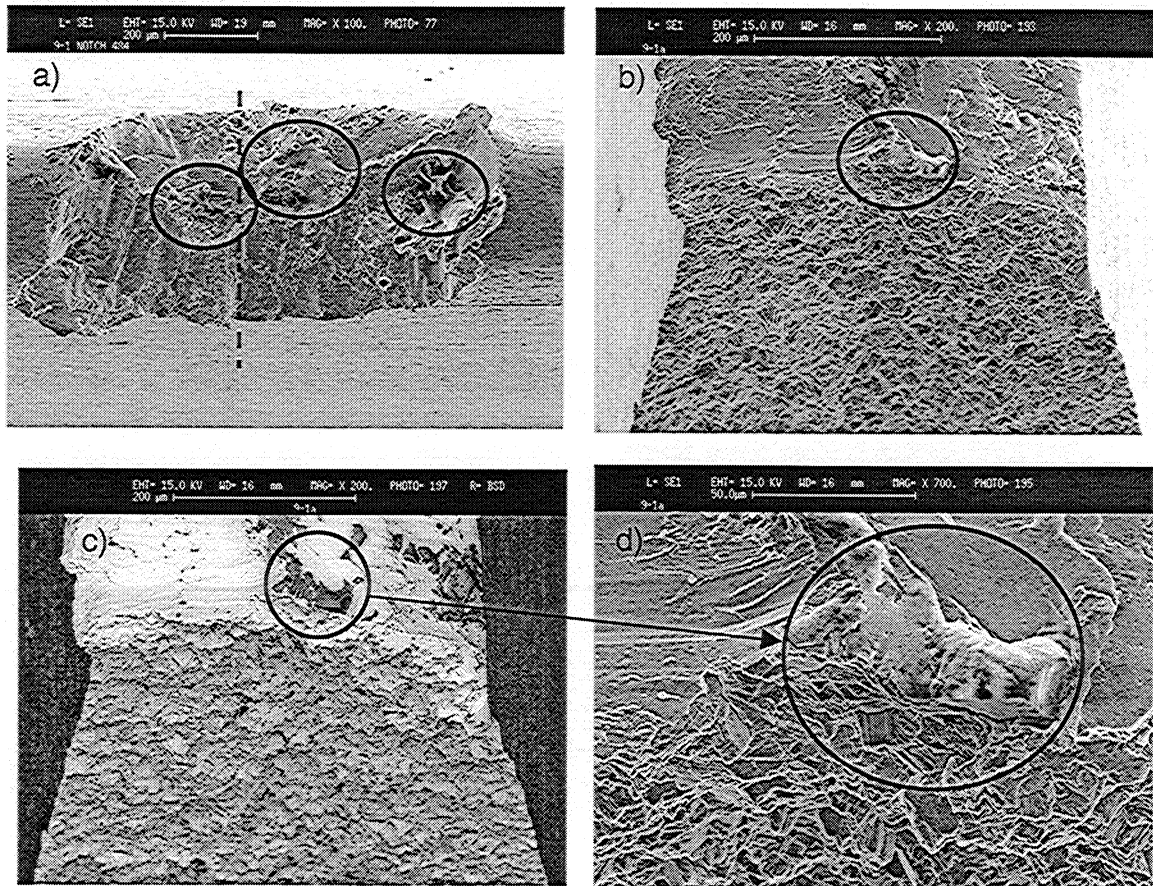
Figure 25: Sample 9-1, 30° impact; a) pre-fracture photo, b) post-fracture, c) backscatter detector image of b, d) close-up of b and c. Embedded glass is indicated by the circle,.

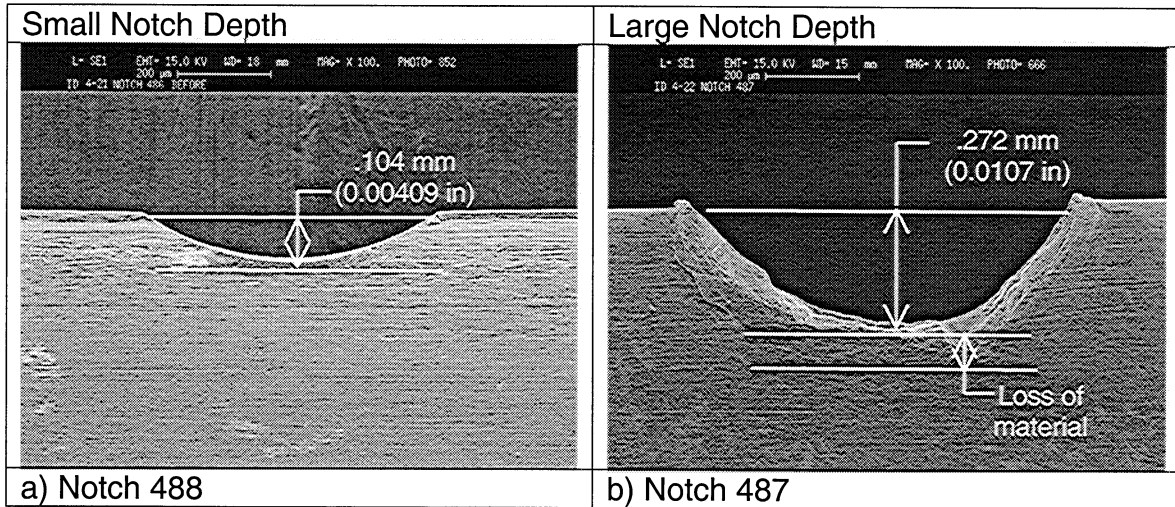
The notch depth was measured by rotating the SEM stage to achieve a profile view of the notch, as shown in Figure 27. These two notches are from the same sample and were impacted at 30°. Figure 27a shows a fairly shallow notch with loss of material and Figure 27b shows a deeper notch with loss of material. Figure 28 is a comparison of the depth of the failed notch, where crack initiation occurred, and the un-failed notch for each specimen impacted at 0°. In most of the cases, where failure initiated at the notch, it failed at the deeper of the two notches. The average damage depth of failed notches is 0.2 mm (0.008”) and 0.12 mm (0.005”) for un-failed notches. The 0° impacts failed at the deeper notch 65% of the time. The 30° impacts failed at the deeper of the two 85% of the time, as shown in Figure 29. Figure 30 shows that the failed notch alone had no direct effect on the normalized fatigue strength.

Figure 27: Characteristic Notch Depth (sharp LE with a 30° impact, sample 4-22)

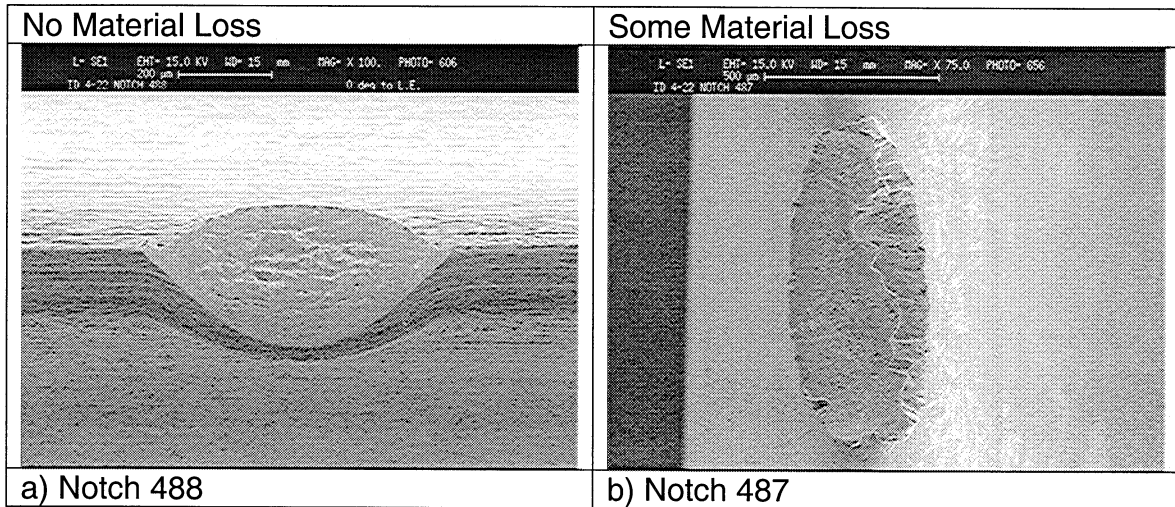
Another feature observed was the loss of material (LOM) from the surface of the notch, which was found on 65% of the failed notches and only 20% of the unfailed notches. This feature was observed and characterized, as shown in Figure 31, by visual estimation using an SEM, where the two notches are from the same sample. Figure 31a illustrates a notch with no material loss and a smooth surface. This is a 30° impact, where the bead seems to have only “dented” the leading edge. On the other hand, Figure 31b shows a rough and jagged notch where there is material loss. Crack initiation occurred at this notch.

Figure 31: Loss of Material (sharp LE with a 30° impact, sample 4-22)

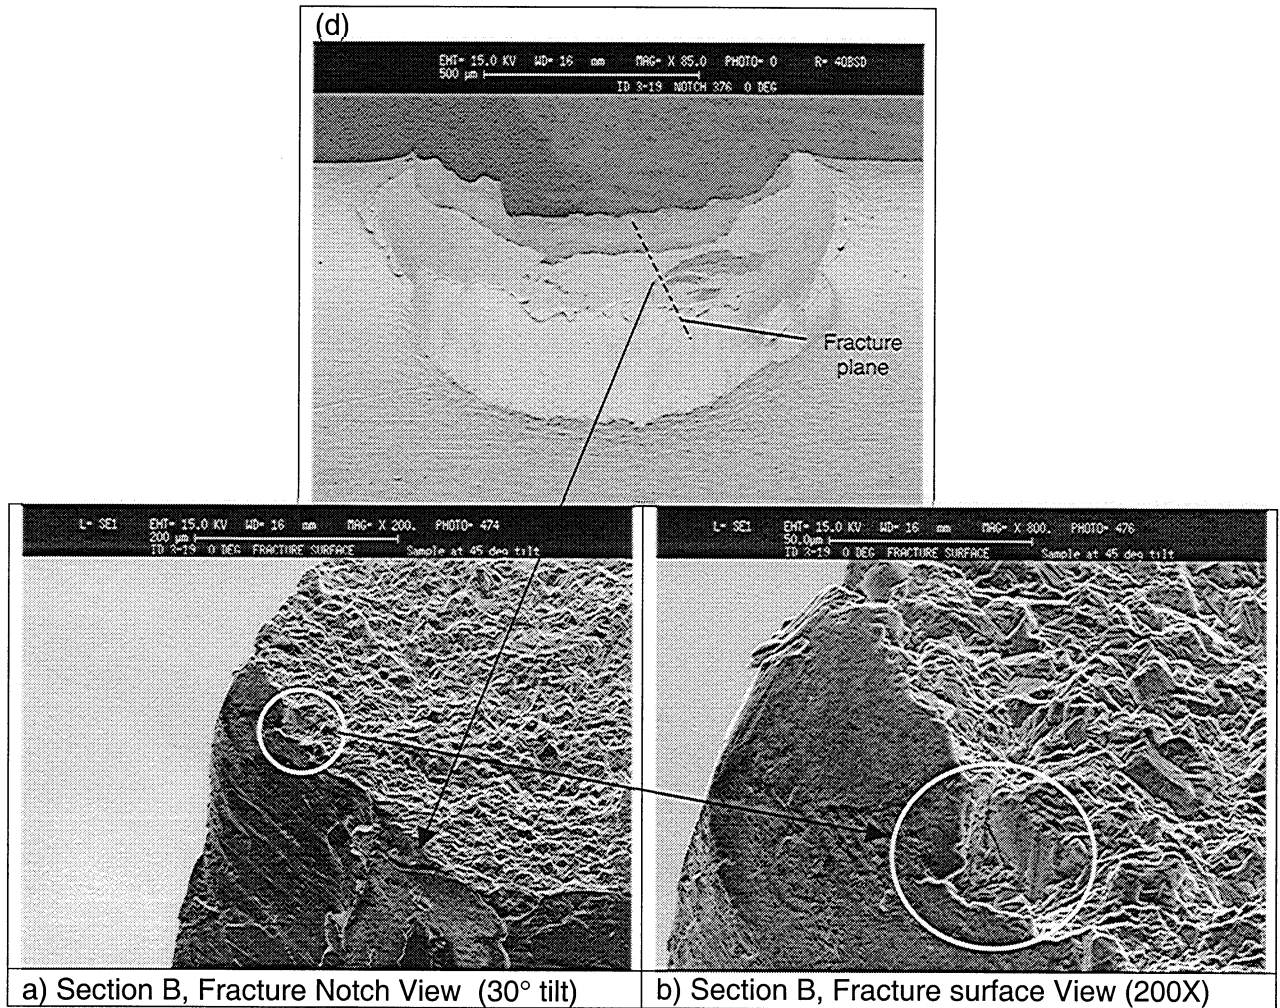
In most cases LOM provides a suitable crack initiation site for failure to occur. Figure 35 illustrates the fracture surface for sample 3-19 (shown in Figure 32c), with a large amount of LOM. In addition to the LOM, the notch contained embedded glass from the shattered bead. The crack did not initiate at the embedded glass, but at a slight fold in the LOM section of the notch denoted by the circle. The depth of this notch was 0.273 mm (0.0107") and the fatigue strength debit of this sample was 49% of an un-notched sample.

Figure 35: Fracture initiation of Sample 3-19 (blunt LE with a 0° impact)

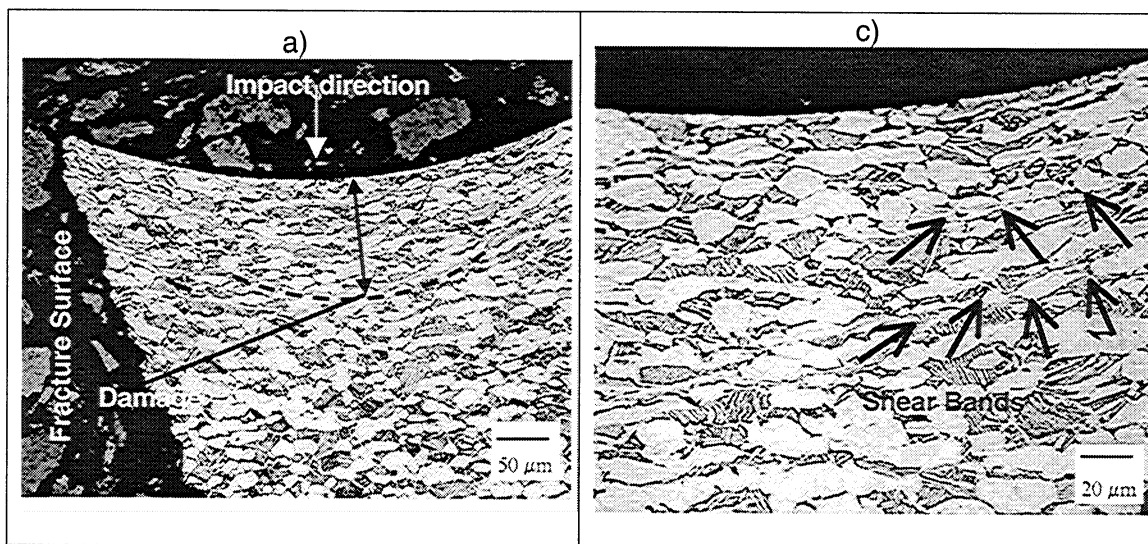
Precision micro-sectioning was performed on a limited number of fatigued samples. An example is shown in Figure 36. These particular photos were taken at the mid-plane of a fractured sample with a 53% fatigue strength debit and a notch depth of 0.21-mm (0.0083"). Evident from each photo is a band of deformed grains along the periphery of the notch, typically 60-100  $\mu\text{m}$  wide. While there was no evidence of subsurface cracking in the direction of eventual crack growth in any of the samples examined, multiple shear bands roughly parallel to the notch were observed in all of the micro-sectioned samples. The fact that these bands are oriented parallel to the applied loading direction (perpendicular to eventual fatigue cracking and to the impact direction) indicates that their presence may have little influence on the fatigue life.

Figure 36: Precision Micro-sectioning of sample 3-13

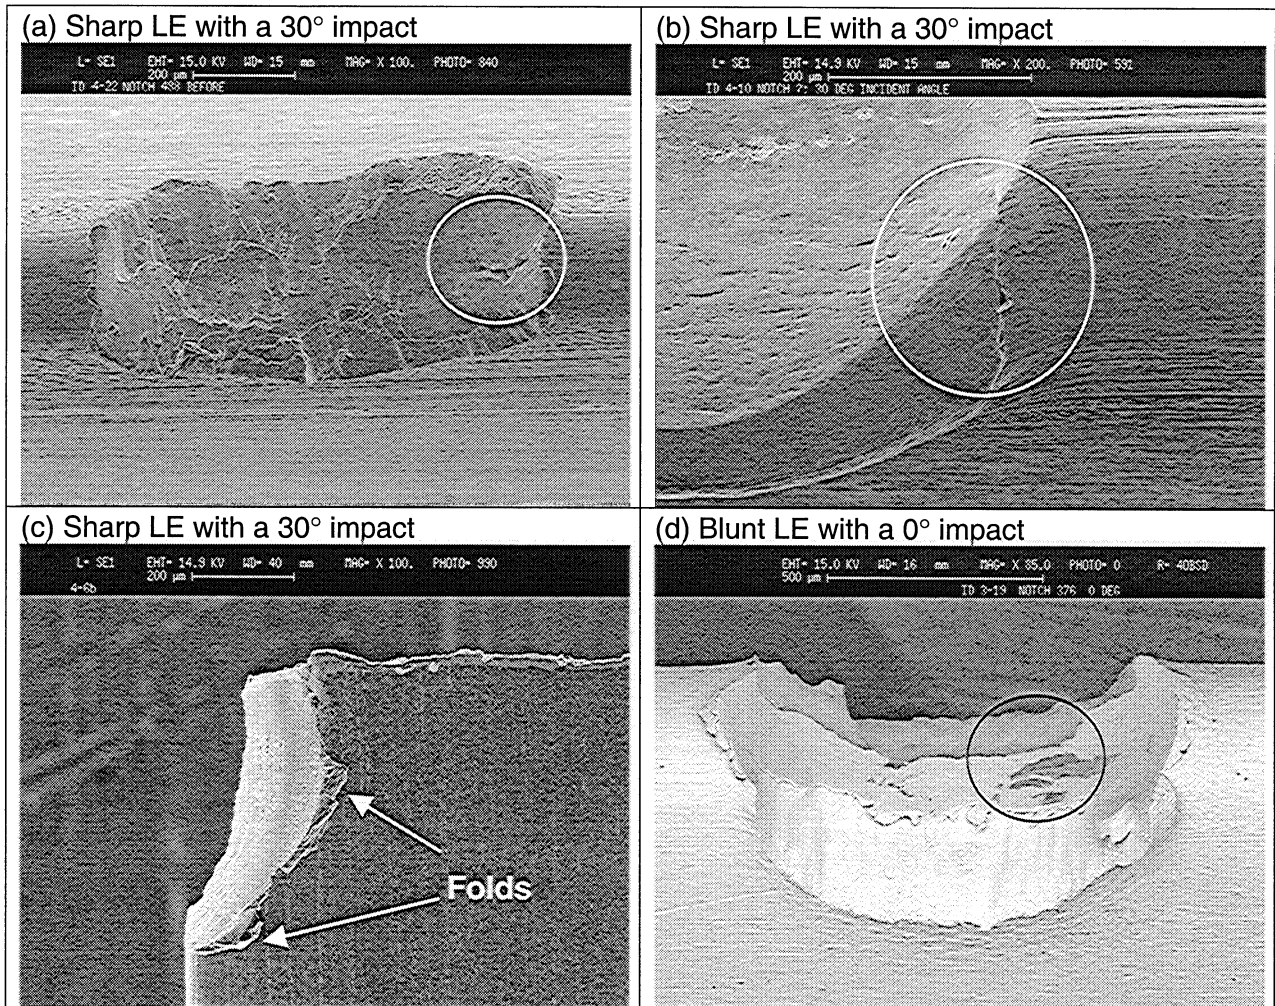
Other damage features that were apparent in the impacts include material shear in the notch region (Figure 37a & b), material folding over the LE (Figure 37c), and embedded glass from the shattered bead (Figure 37d) which was confirmed by energy dispersive spectroscopy, shown in Appendix B. None of these features alone appeared to have any significant effect on the fatigue strength. On the other hand, shearing and folds did provide suitable crack initiation sites for some of the samples. Figure 38 illustrates the fracture of sample 3-4, which had a notch depth of 0.182-mm (0.0071") and a fatigue strength debit of 64%. The pre-fracture condition of the notch indicates a material shear (or tearing) indicated by the circle in Figure 38a. The post-fracture condition of the notch shows that the fracture initiated somewhere behind the material shear, Figure 38b & c.

Figure 37: Other damage features: a) material shear; b) material shear; c) material fold; d) embedded glass, backscatter detector mode

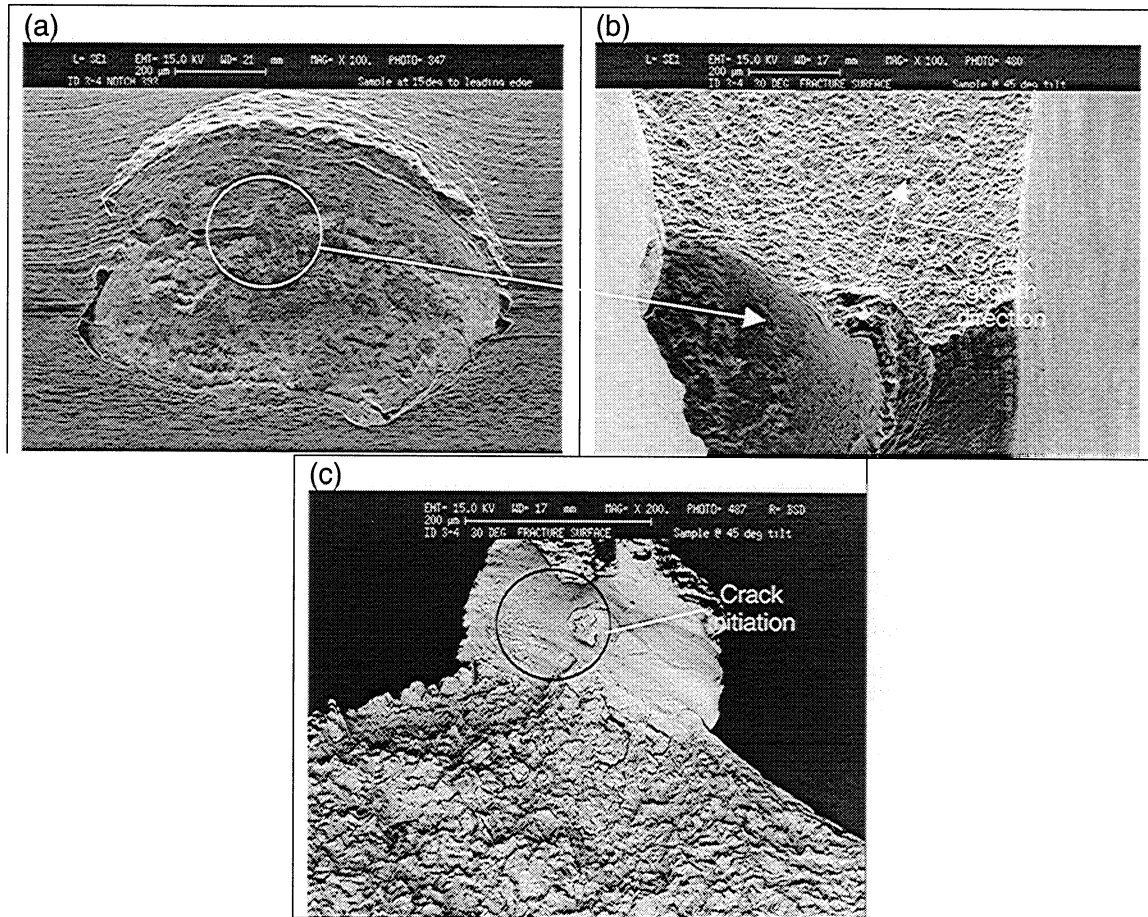
Figure 38: Shearing: a) Before fracture picture of sample 3-4 with a blunt LE and a 30° impact, material shear parallel to LE b) After fracture photo; c) After fracture photo behind material shear

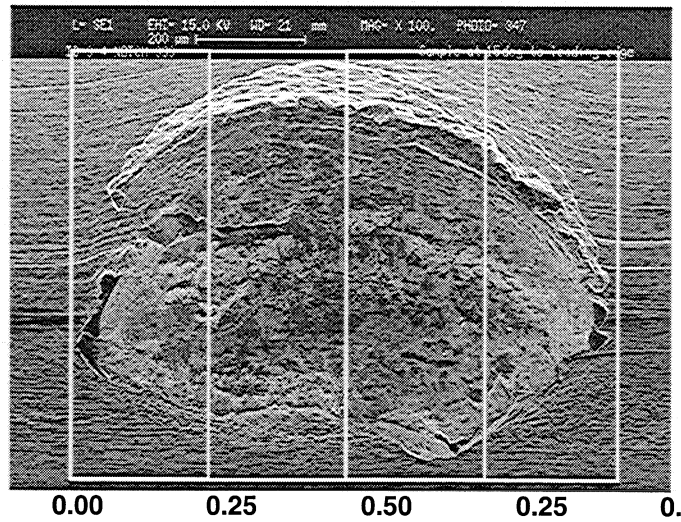
Previous research shows that fatigue failures of samples ballistically damaged with larger steel balls at similar velocities failed at the edge (rim) of the notch<sup>7,10</sup>. Data in the present research program found that failure generally occurred in the central region of the notch (indicated by the 0.25-0.50 region in Figure 39). Regardless of the condition (notch depth, LOM, shearing, or embedded glass) of the notch, failure occurred at or near the center of the notch for 30° impacts. There is no clear correlation for 0° impacts, partially due to data scatter and a limited number of data points, as seen in Figure 40. The difference in the failure sites between this and previous work may be due to the heavier ball that was used and the resulting impact damage in the case of the previous studies. In addition, Ti-6Al-4V flat specimens were used in the previous research and were impacted on the flat surface of a larger fatigue specimen as opposed to this investigation in which thin samples were impacted on the edge; the latter being more representative of an actual airfoil edge.

Figure 39: Crack Initiation Location photograph
